# Virginia Department of Forestry BMP Effort, Implementation, and Effectiveness Field Audit

December 2006

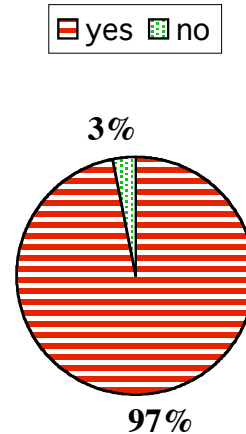
Efforts to implement BMPs were evident at 97% of inspected timber harvests, down from the 98% recorded in November 2005, (*fig.1*). Quality of effort, rated on a scale of 1(poor) to 5(excellent), averaged 3.3 up from the 3.2 average of November 2005. Implementation of all necessary BMPs to DOF standards occurred at

Fig. 1: Has An Effort Been Made To Apply BMPs, Regardless Of Meeting Technical Specifications?

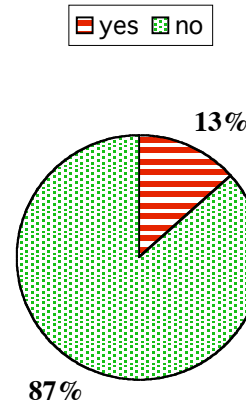
13% of inspected sites, down from the 18% recorded in November 2005 (*fig. 2*).

Fig. 2: Were All BMPs Applied To Technical Specifications As Expressed In The BMP Manual?

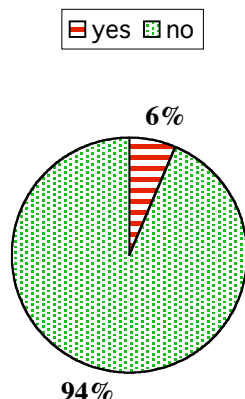
Active sedimentation existed at 7% of the inspected sites, up from the 3% recorded in November 2005, (*fig. 3*). The potential for sedimentation was noted at 10% of the inspected sites, equivalent to the 10% noted in November 2005, (*fig. 4*).

**Fig. 3: Does Active Sedimentation Exist Now Because BMP Technical Specifications Were Not Met?**

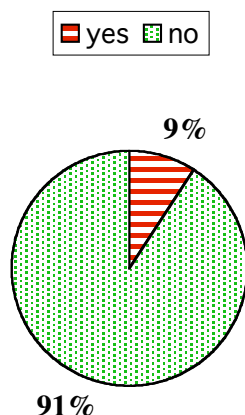
**Fig. 4: Does The Potential Exist For Active Sedimentation To Develop Because BMP Technical Specifications Were Not Met?**
